## INFORMATION REPORT

SUBJECT Dozsa Barracks in Nagykanizsa

a. Sketch of the Nagykanizsa Dozsa Military Barracks.

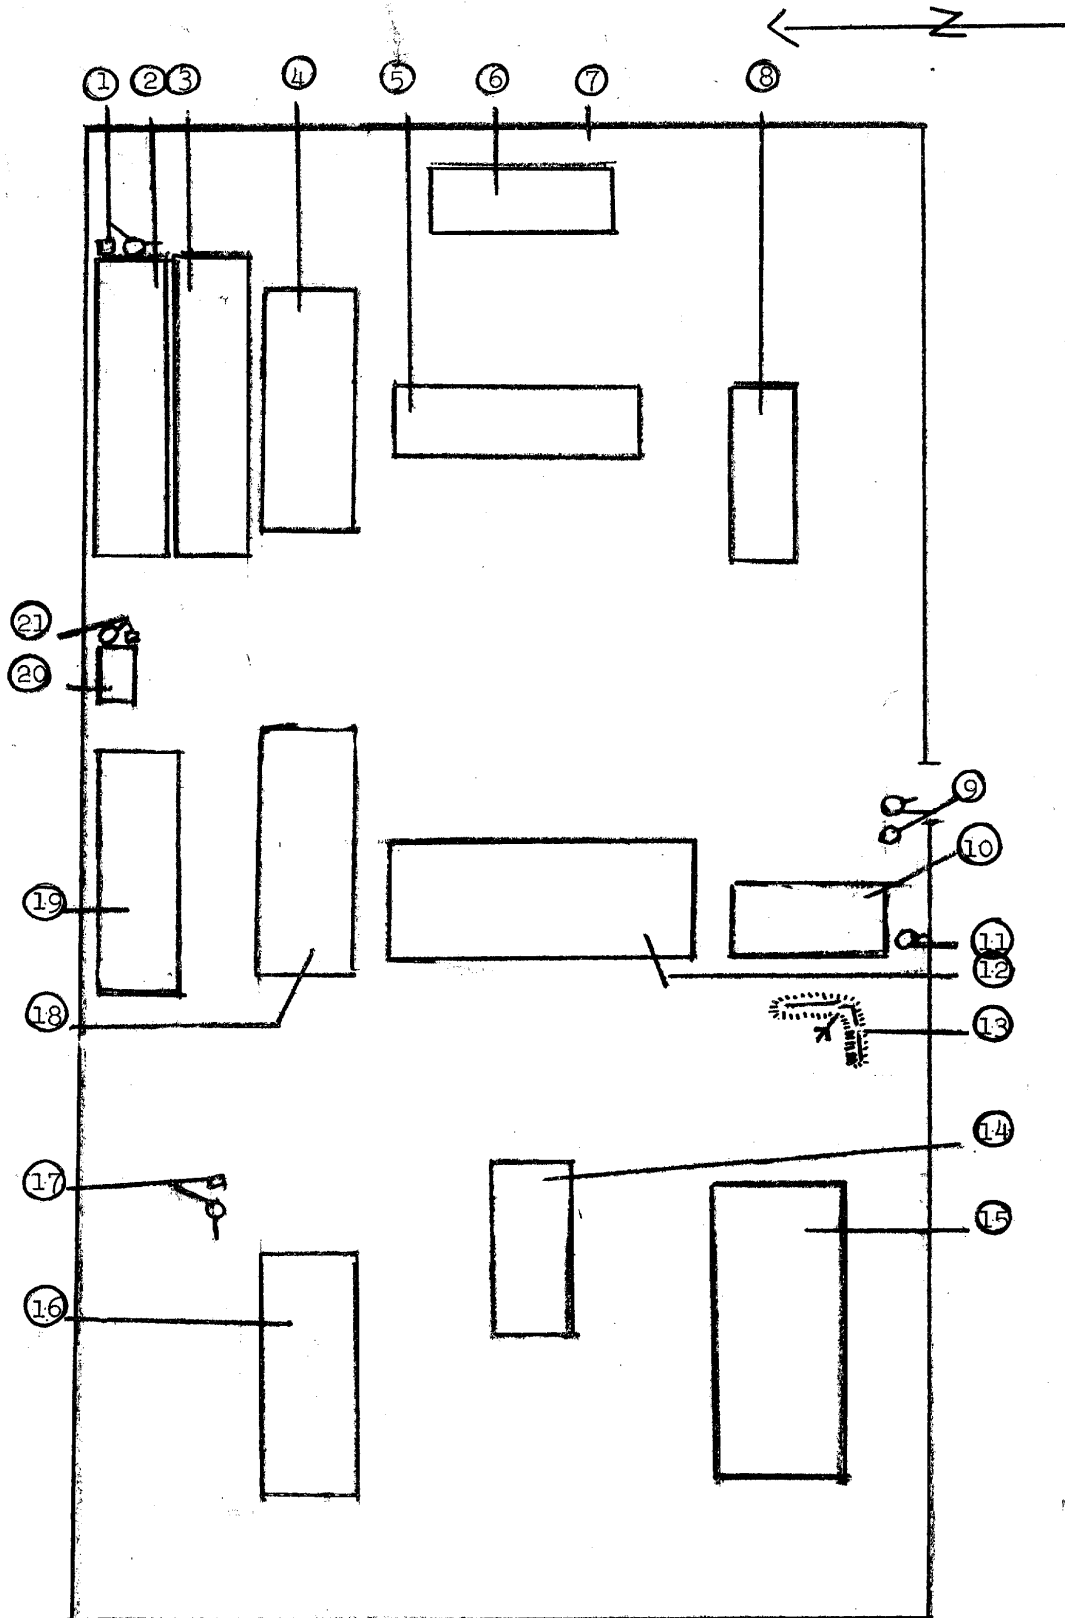
Sketch of the Nagykanizsa Dozsa Military Barracks

1. Sentry and Sentry House, Post #6. Sentry equipped with rifle, guard changed every two hours. Sentry shack was small, wooden, one-man type. Post included all area along east fence.

2. Barn, 25 x 10 x 6 m., single story, brick construction, hipped tiled roof. Building was used to store silage for horses.
3. Artillery Storage Building, single story, concrete construction, flat deck type roof, built in 1950, 25 x 10 x 6 m. Used to garage six pieces of 57 mm. gun and three pieces of 76 mm. gun.

4. Troop Barracks, two-story, brick construction, hipped tiled roof, basement, 20 x 8 x 18 m. Housed 125 troops of the 1st Inf. Regt.
5. Stable, single story, brick construction, hipped tiled roof, 20 x 6 x 8 m., housed 8-10 horses used by officers.

6. Wagon Garage, single story, brick construction, hipped tiled roof, 16 x 6 x 8 m. Housed two pieces of 45 mm. AT gun and unknown number of other caliber artillery guns.

7. Fence, heavy wire mesh, barbed wire top, enclosed camp area of 200 x 100 m. Fence in poor repair, 2.5 m. high.
8. Headquarters Building, two story, brick construction, hipped tiled roof, basement, 20 x 18 x 8 m. Used as 1st Inf. Regt. Headquarters offices, also partly as dispensary.

9. Sentry and Sentry House, Post #2. Sentry equipped with rifle, guard changed every two hours. This sentry checked passes and orders carefully.
10. Guard House, single story, brick construction, hipped tiled roof, 14 x 6 x 8 m. Camp stockade and sentry room.

11. Sentry, Post #1. Sentry equipped with rifle, guard changed every two hours. Sentry was responsible for manning mounted machine gun Point 13, this report, and also covered entrance to guard house Point 10, this report.

12. Recreation Hall, single story, brick construction, hipped tiled roof, basement, 25 x 10 x 8 m. Contained stage, showers, game room.
13. Sand Bag Revetment, 1.5 m. high with wings 2.5 m. long. One 30 caliber tripod machine gun permanently installed, manned by sentry #1.

14. Officers' Canteen, single story, concrete construction, flat deck type roof, 14 x 6 x 8 m. used as canteen and snack bar, constructed late 1949.
15. Headquarters Building, three story, brick construction, hipped tiled roof, basement, 24 x 10 x 20 m., used for artillery regiment designation unknown.

16. Troop Barracks, two-story, brick construction, hipped tiled roof, basement, 20 x 8 x 18 m. Housed 150 artillery troops.
17. Sentry and Sentry House, Post #3. Sentry equipped with rifle, guard changed every two hours. Post included all of area in northwest portion of camp between building Point 16 and fence.

18. Troop Barracks, two-story, brick construction, hipped tiled roof, basement, 20 x 8 x 18 m. Housed 1st Inf. Regt. troops, along with mess hall.
19. Stable, single story, brick construction, hipped tiled roof, 18 x 6 x 8 m. Housed 28-30 horses used to pull ammo wagons and AT guns.

20. Ammunition Storage Building, single story, concrete construction, flat deck type roof, constructed in 1950. Contained artillery ammo along with small arms ammunition.

21. Sentry and Sentry House, Post #4. Sentry equipped with rifle, guard changed every two hours. Post included area around ammunition storage building.
